# **Inspection Report**

123 Riverside Drive Petoskey Michigan 49770

**Big Moose Home Inspections, Inc.**

<b>Date:</b> 9/1/2023	<b>Time:</b> 02:00:00 PM	Report ID: Sample Report
<b>Property:</b> 123 Riverside Drive Petoskey Michigan 49770	<b>Customer:</b> Jane Smith	Real Estate Professional:

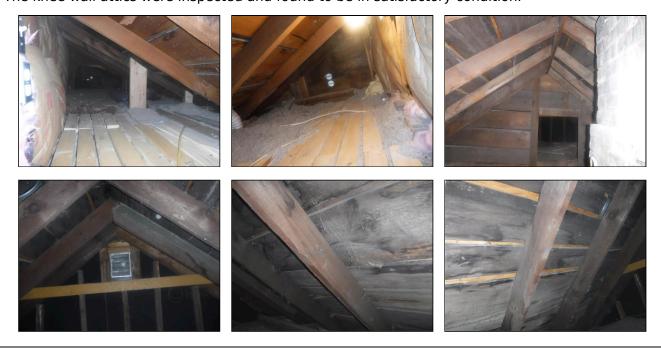
(1) There was no main over the ceiling attic. Roof structure, examined from the interior and exterior, showed no visible defects or moisture damage.

(2) The knee wall attics were inspected and found to be in satisfactory condition.
